HD-Stabilizer links

MEYLE-HD

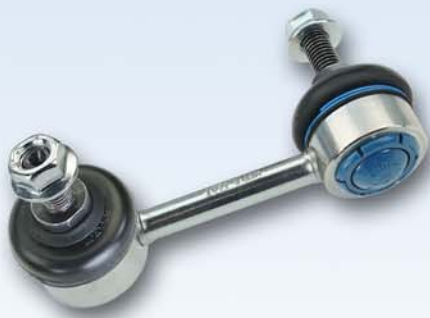
As OE

Problem

Intense strain causes wear and stress of the components

Effect

Premature failure of the ball joint
Noise from the front axle

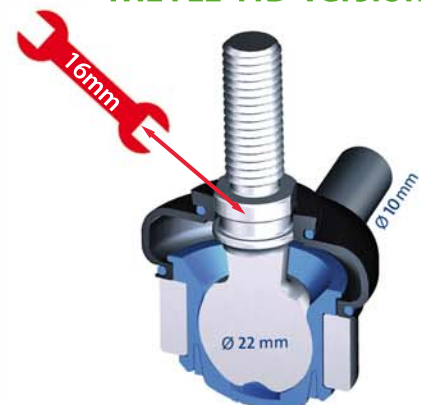
MEYLE-HD version

- Enlarged ball diameter (22mm)
- Reinforced link rod
- MEYLE high-tech grease
- Wear resistant blue plastic seat

Significantly longer service life thanks to reinforced design
